# 82527

## Specification Update

*August, 2004*

Order Number: **272876-003**

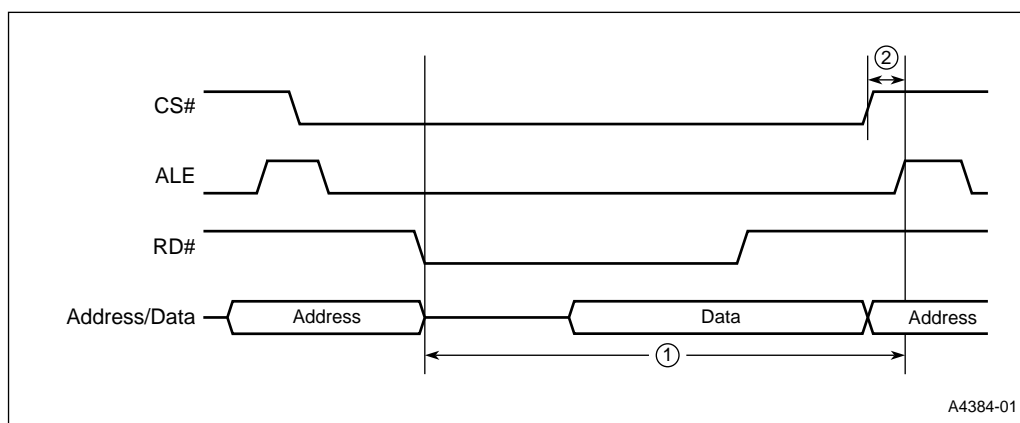
**Figure 1. Bus Cycle for Mode 0 or Mode 1 Operation (Read Cycle)**

For mode 0 and mode 1 (Intel multiplexed modes), the control signals ALE, RD# and WR# are used to define the address and whether the cycle is a data read or write operation. The ALE signal is commonly used to latch the address information and generate a CS# signal to the 82527. The problem occurs in this configuration when the next cycle ALE is asserted before CS# of the current cycle becomes invalid. This circumstance presents a problem only when CS# is active and the next cycle’s ALE occurs less than  $1.5 t_{MCLK}$  after the current cycle’s RD# low. ( $t_{MCLK} = t_{OSC}/[(1 + DSC \text{ bit}) + DMC \text{ bit}]$  where DSC = Divide System Clock, DMC = Divide Memory Clock.

When performing “fast reads” associated with the double-read operation in mode 0 or 1, one of the following two conditions must be true:

1. The time from RD# low of the current cycle to the next ALE must be greater than  $1.5 t_{MCLK}$ , or
2. The CS# signal to the 82527 must be inactive before the next occurrence of an ALE, when the time from the RD# low of the current cycle to the next cycle’s CS# active is less than  $1.5 t_{MCLK}$ .

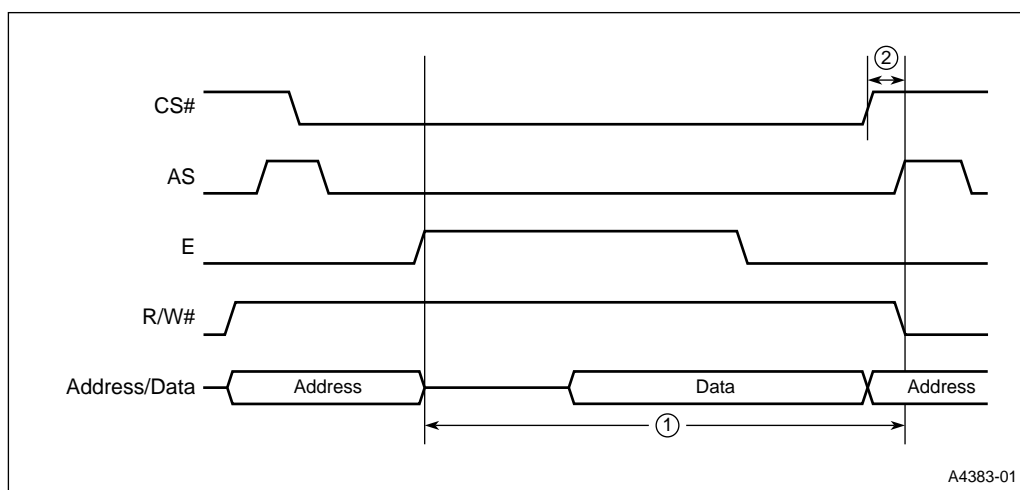
**Figure 2. Bus Cycle for Mode 2 Operation (Read Cycle)**

For Mode 2, the control signals AS, R/W#, and E are used to define the address, to specify whether the cycle is a data read or write operation, and to synchronize the memory accesses. The AS signal is commonly used to latch the address information and generate a CS# signal to the 82527. The problem, as outlined for Modes 0 and 1, occurs when the next cycle's AS is asserted before CS# of the current cycle becomes invalid. This circumstance presents a problem only if the next cycle's AS occurs in less than  $1.5 t_{MCLK}$  after the current cycle's E low while CS# is still active.

For Mode 2 operation, one of the following two criteria must be true:

1. The time from E high of the current cycle to the next AS must be equal to or greater than  $1.5 t_{MCLK}$ , or
2. The CS# signal to the 82527 must be inactive before the next occurrence of an AS, when the time from E high of the current cycle to the next cycle CS# active is less than  $1.5 t_{MCLK}$ .

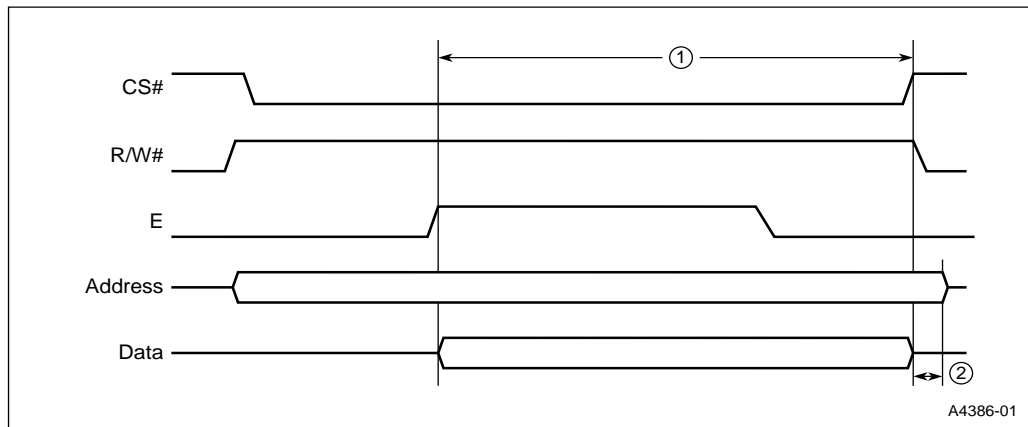
**Figure 3. Bus Cycle for Mode 3 Synchronous Operation (Read Cycle)**

For mode 3 synchronous operation, there is no ALE or AS signal. Mode 3 is the demultiplexed mode of the 82527. For this mode, the address information must be present through the entire cycle. However, when performing fast read operations, similar considerations as the other modes must be observed to prevent problems when performing reads from the 82527.

For mode 3 synchronous operation, one of the following two criteria must be true:

1. The time from E high of the current cycle to CS# invalid must be equal to or greater than  $1.5 t_{MCLK}$ , or
2. Address information must remain valid on the bus until after CS# goes inactive.

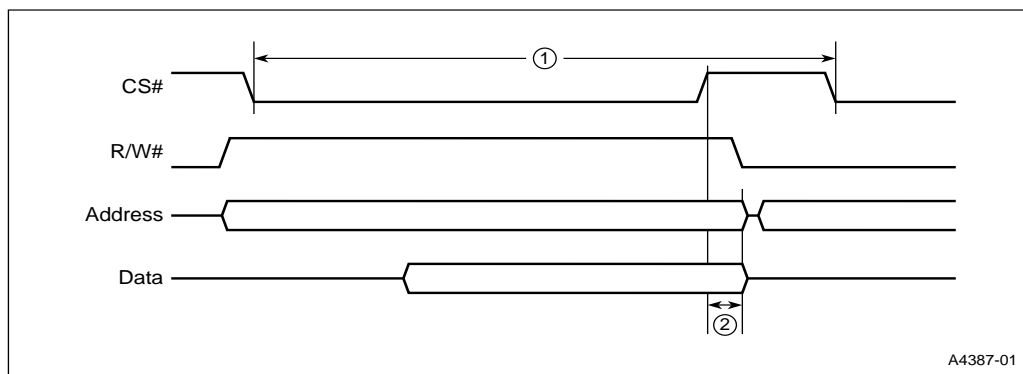
**Figure 4. Bus Cycle for Mode 3 Asynchronous Operation (Read Cycle)**

Mode 3 asynchronous is also a demultiplexed mode of operation on the 82527. This mode is typically used with the DSACK0# signal. When using mode 3 asynchronous with host CPUs that do not have the DSACK0# input, the following considerations must be observed to prevent problems when performing reads of the 82527.

For Mode 3 asynchronous (no DSACK0#), both of the following criteria must be true:

1. The time between consecutive CS# cycles must be equal to or greater than  $2 t_{MCLK}$ .
2. Address information must remain present on the bus until after CS# goes inactive.
